# Special Report 84-2

## *Ice observation program on the semisubmersible drilling vessel SEDCO 708*

L. David Minsk

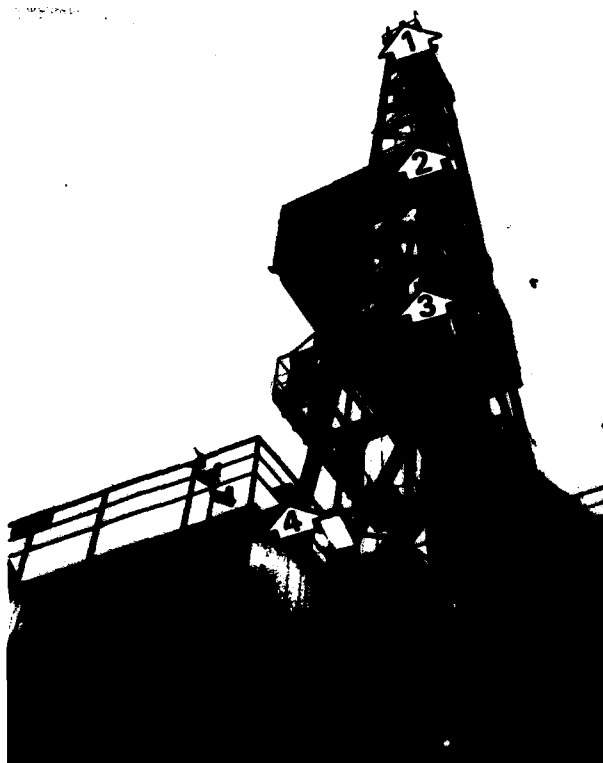
Figure 3. Locations of Rosemount ice detectors on derrick. Heights (above deck) are 1 - 180 ft; 2 - 120 ft; and 3 80 ft. Number 4 is on the railing above the diving bell area, about 20 ft above deck.

Three of the ice detectors were located on the derrick at heights above the deck of 80, 120 and 180 ft (Fig. 3). The fourth detector was mounted on the railing on the roof of the diving bell storage area, about 20 ft above the deck.

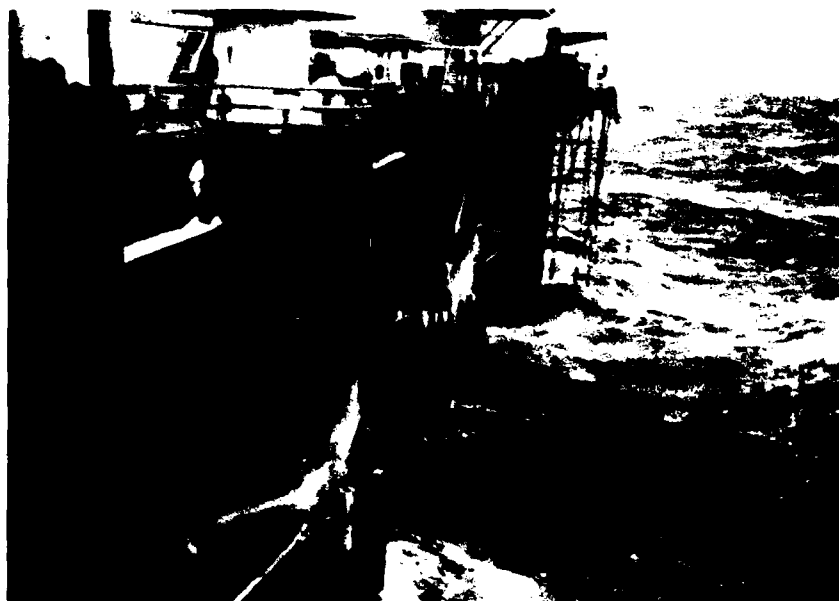
Contrary to what one might expect, the windward columns (those facing north) accreted very little ice even though the timber bumpers on the central two columns should have because they offered increased area above the wave zone (Fig. 7 and 8). Accumulation was heaviest on the diagonal cylindrical trusses in the central part of the structure, where ice thickness up to approximately 5 in. was estimated by scaling photographs (Fig. 9 and 10). The lower third of the exposed stiffeners was scoured by wave action and was completely ice-free, and accumulation tapered off with height, that is, as the underside of the deck was approached. No ice accreted on the underside of the deck (Fig. 11); as waves broke or crashed against the structure, the droplets that were generated were carried in clouds that diminished in height as they passed under the deck, and no droplets appeared to reach the underside of the deck. Only a rough estimate of the total mass of ice that was accreted can be made by scaling photographs; the

Figure 7. Minor ice accumulation on north-facing columns (starboard, windward side). View approximately west (6 January 1983).

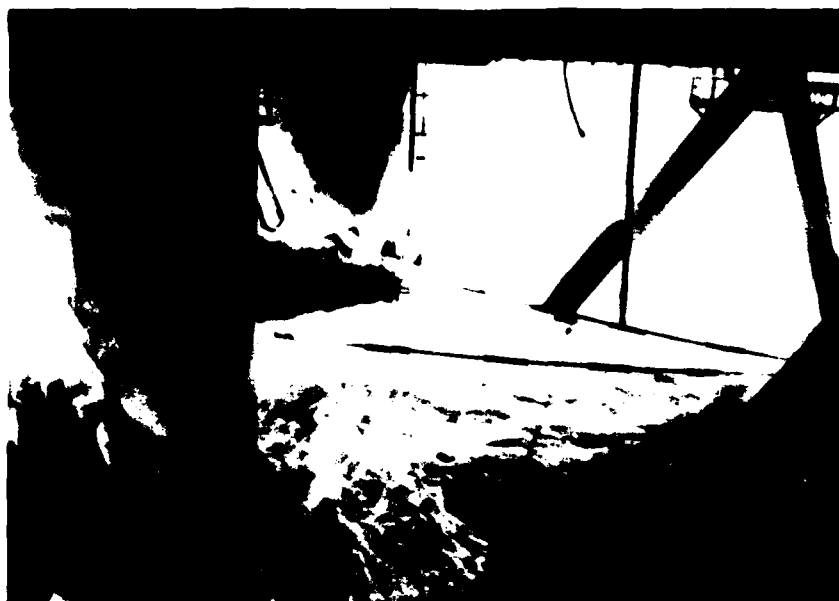
Figure 8. View east from below-deck porthole of starboard aft columns (lee to right). Only slight icing occurred (6 January 1983).

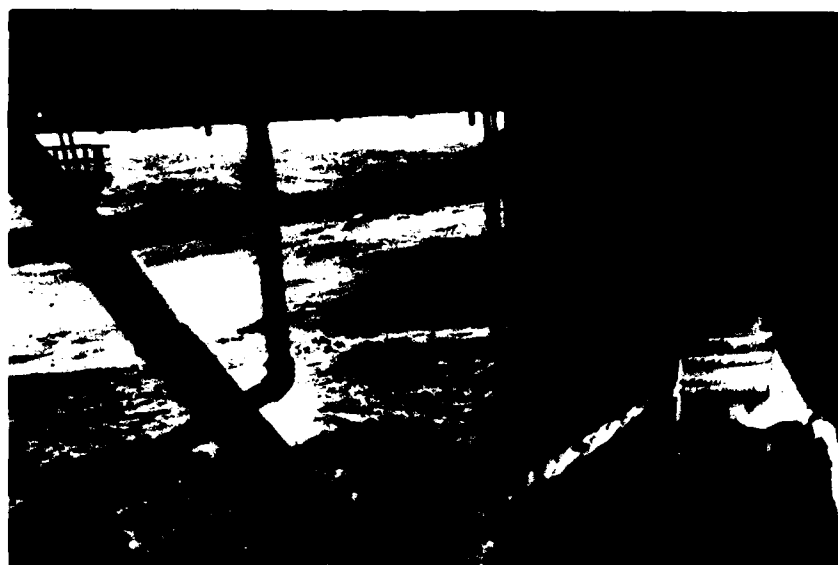
Figure 11. View southwest from below-deck porthole of forward port column; note that underside of deck has no ice accumulation (6 January 1983).
